Local Flood Analysis

**Village of Tannersville
Greene County, New York
January 2018**

MILONE & MACBROOM®

Village of Tannersville
Greene County, New York
January 2018

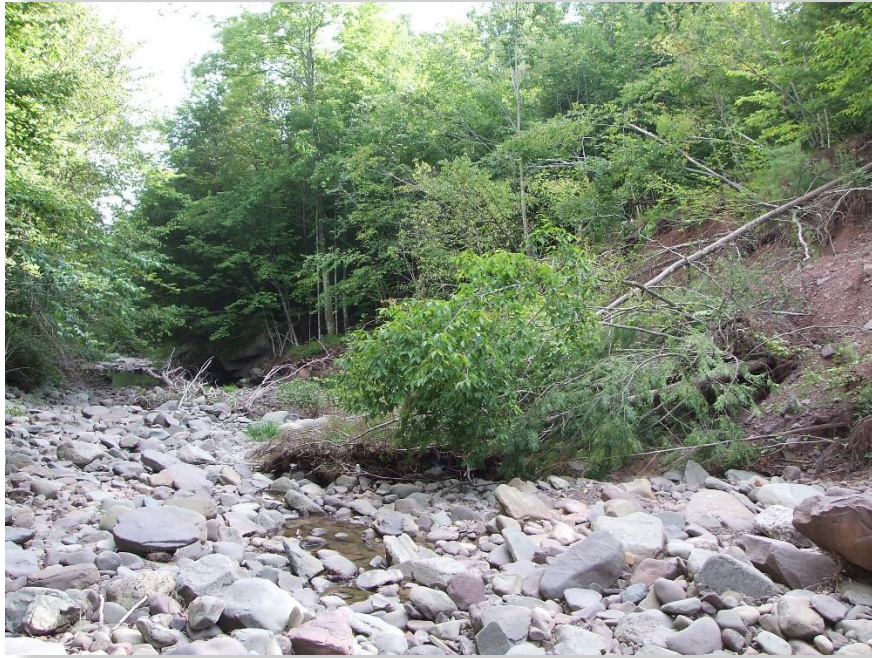
Figure 3-3
Sawmill Creek Channel near Sylvan Street

businesses. Figure 3-3 shows the Sawmill Creek channel upstream of Main Street in the vicinity of Sylvan Street.

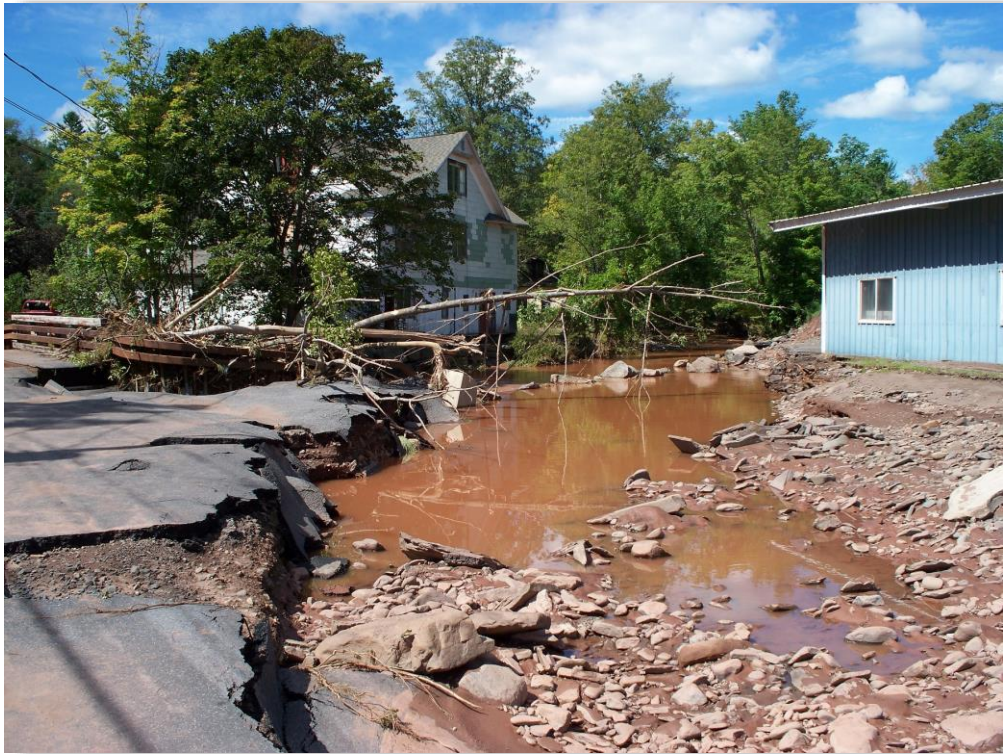
Figure 3-4
View of the Railroad Avenue bridge on the left and the DPW garage
on the right the day after the flood

The most severe damage along Sawmill Creek occurred along Railroad Avenue between the GCSWCD building and Gooseberry Creek. Upstream of the DPW facility, Sawmill Creek left its banks and ran down Railroad Avenue, resulting in extensive damage to the DPW facility, Legg's Garage, and the roadway itself (Figures 3-4 through 3-6). It was reported that there was about 3.5 feet of water in the DPW facility and 4 feet at Legg's Garage and the former Mountain Eagle News building.

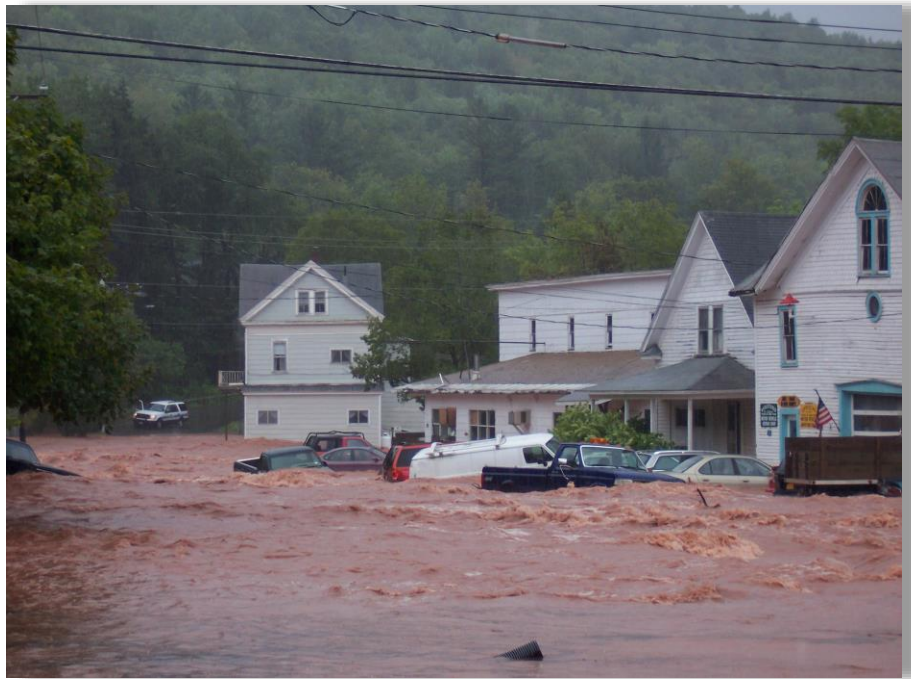
Figure 3-5
View of Railroad Avenue and Legg's Garage during the flood

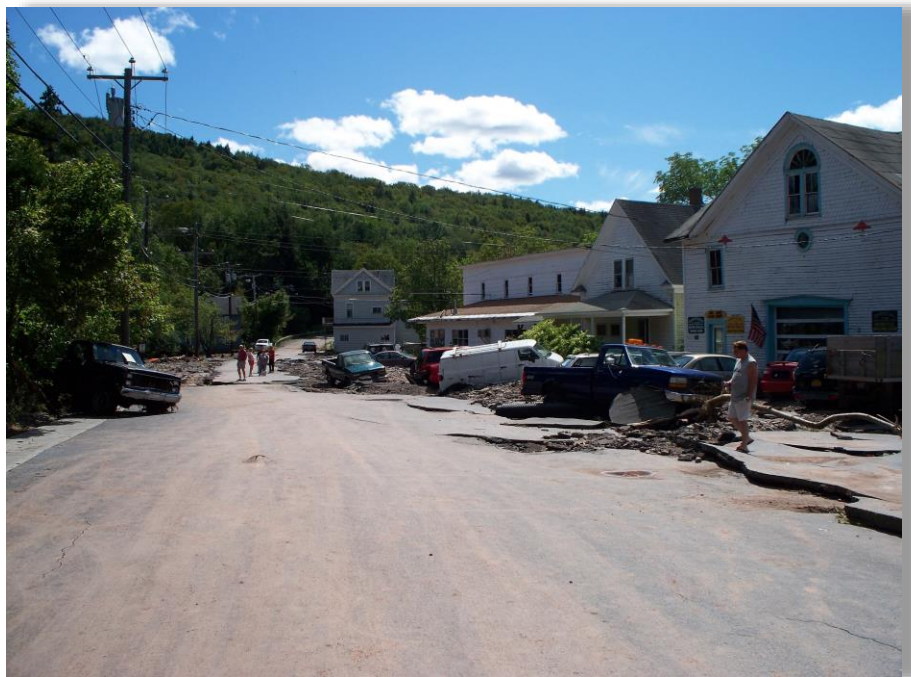
Figure 3-6
View of Railroad Avenue and Legg's Garage the day after the flood

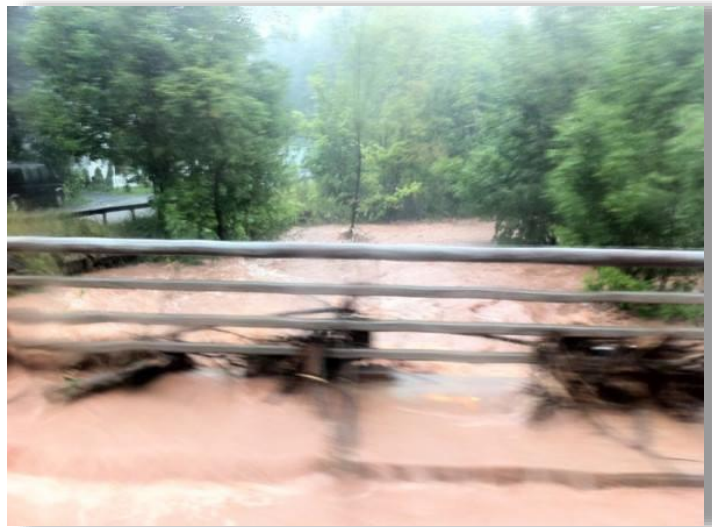
Figure 4-3
Main Street Bridge over Sawmill Creek overtopping in Tropical Storm Irene

Under current conditions, the bridge is able to pass the 10-year discharge. In contrast to the 10-year discharge, the 50-, 100-, and 500-year events all overtop the bridge. The bridge was overtopped during the Tropical Storm Irene flood in August 2011 (Figure 4-3).

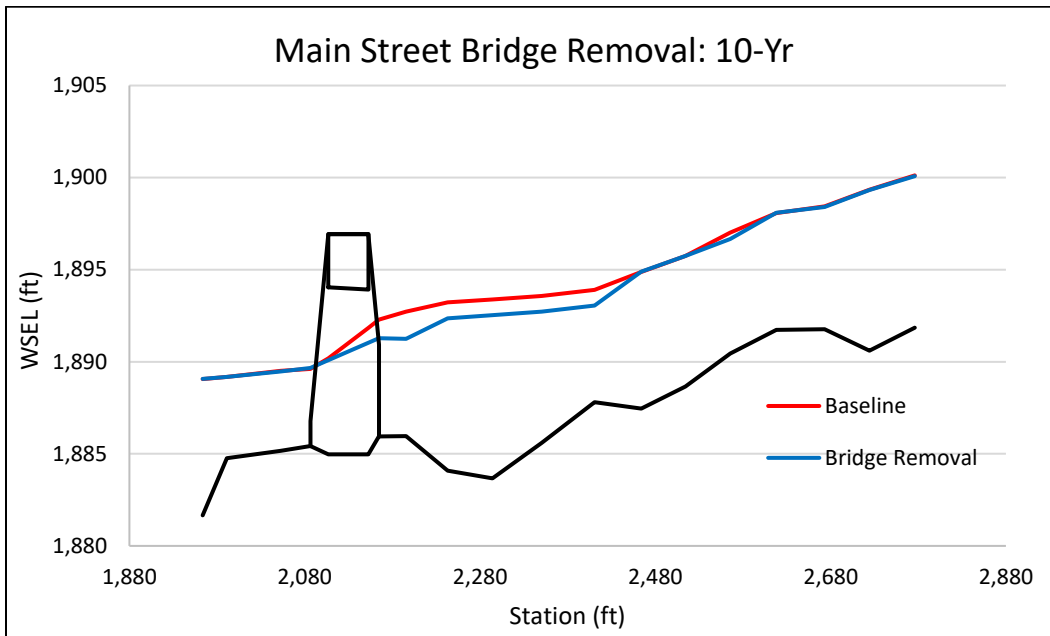
Figure 4-4
 Change in Water Surface Elevations at the Main Street/State Route 23A Bridge
 over Sawmill Creek: 10-Year Discharge

The 10-year flood event passes through the bridge without overtopping, and removal of the bridge from the hydraulic model results in minimal reductions in water surface elevation upstream of the bridge (Figure 4-4). During the 50-year flood event, removal of the bridge from the model results in decreases in water surface elevations, with reductions of nearly 4 feet immediately upstream of the bridge (Figure 4-5). Similar reductions in water surface elevations also occur under the 100-year event and extend a distance of approximately 300 feet upstream of the Main Street bridge (Figure 4-6). Under the bridge removal scenario, a reduction of 2.5 feet is seen at the bridge opening during the 500-year discharge. However, flooding is so extensive that removal of the bridge provides little to no benefit.

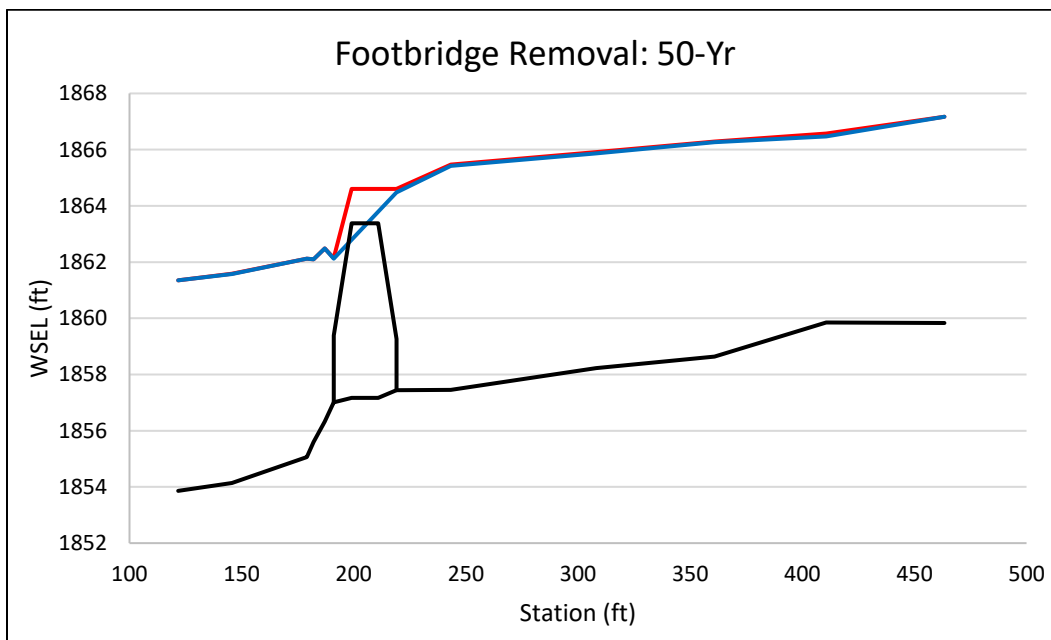
Figure 4-10
 Change in Water Surface Elevations at the Rail Trail Footbridge
 over Sawmill Creek: 50-Year Discharge

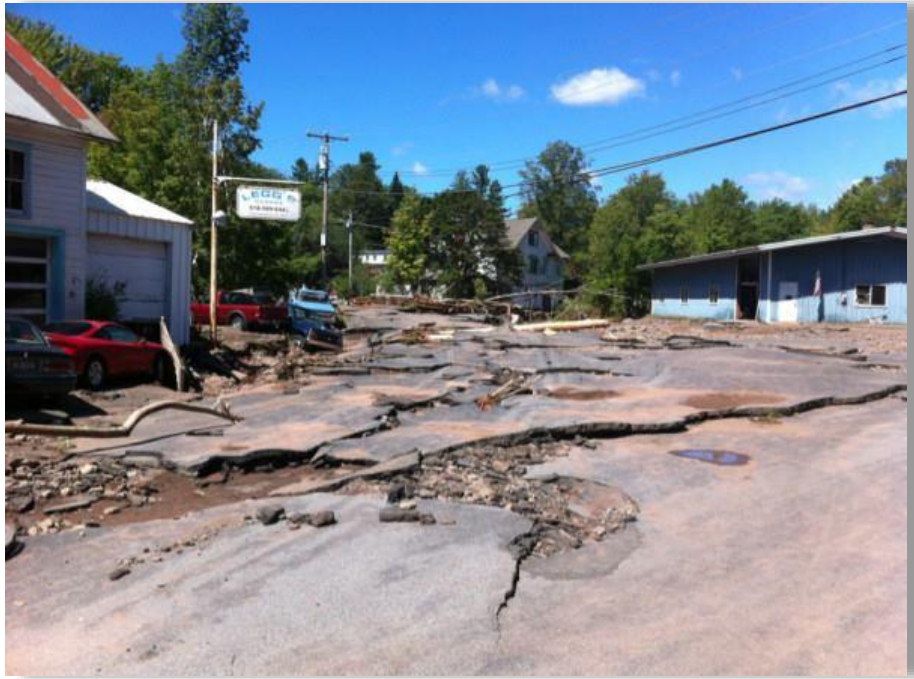
Figure 4-25
Tannersville Highway Department Garage following Tropical Storm Irene

The report concludes by stating that the repair costs for a building at this location exceed the capital costs for the building (which excludes the cost of flood damaged equipment and lost materials), which indicates that the continued use of a structure at this site is cost prohibitive to the village.

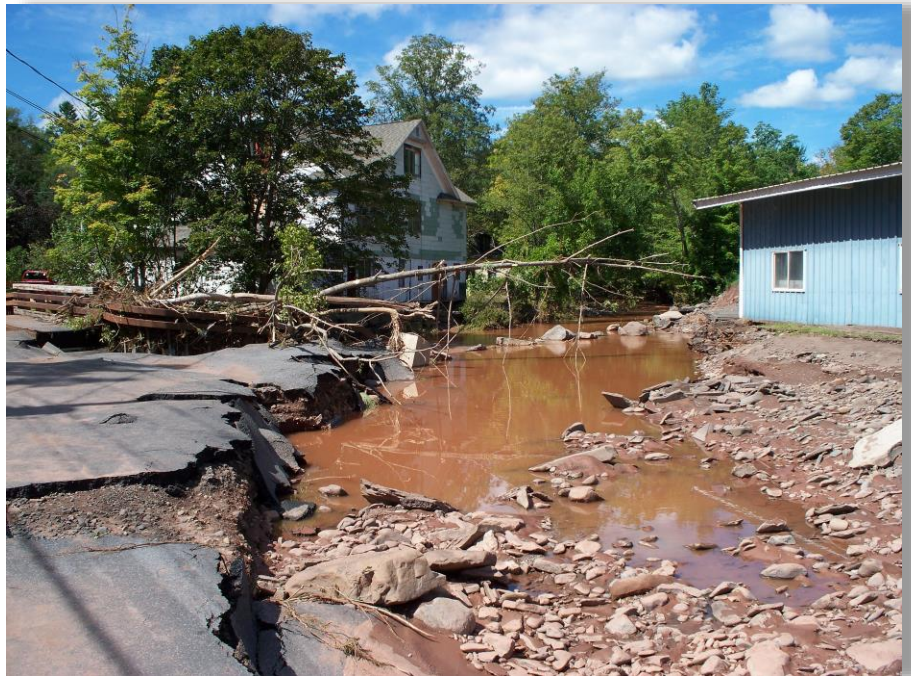
Figure 4-26
Tannersville Highway Department Garage following Tropical Storm Irene

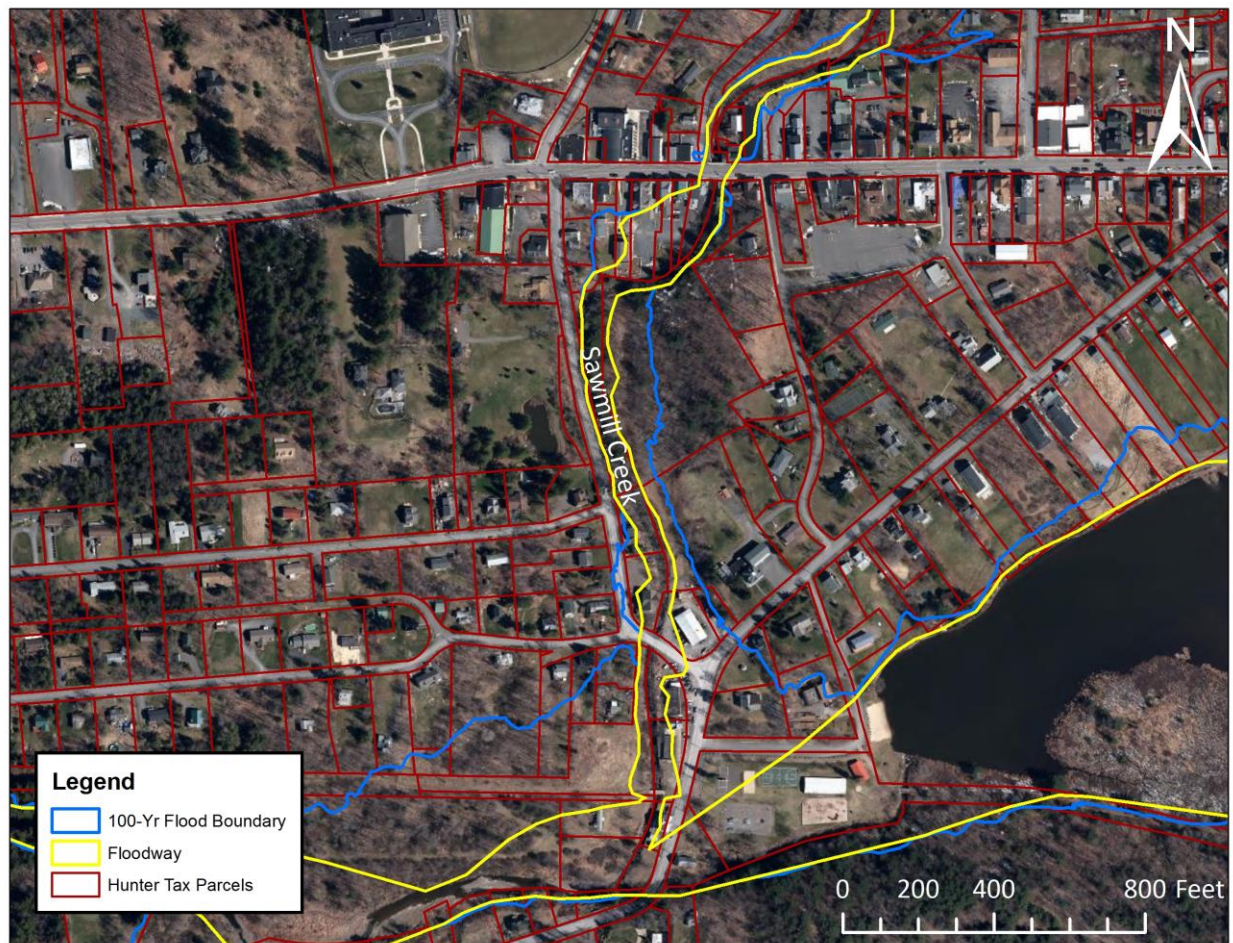
Figure 4-27
Map of Tannersville showing FEMA Floodway

Several structures, some occupied and some abandoned, were identified in Tannersville that are located fully or partially within the floodway (Figure 4-27). The floodway, designated by FEMA, is the stream channel, and that portion of the adjacent floodplain must remain open to permit passage of the base flood. Floodwaters are typically deepest and swiftest in the floodway, and anything in this area is in the greatest danger during a flood (FEMA, 2008). Where there is owner interest and programmatic funding available, it is recommended that existing structures be relocated out of the FEMA-designated floodway. Structures located fully within the floodway are at high risk of flooding while those located partially within the floodway may be less at risk. Decisions about relocations will need to take place on a case-by-case basis, depending on the location of each structure and each structure's past history of flood damage. It is also recommended that any new development or elevation of existing structures in the floodway be disallowed.

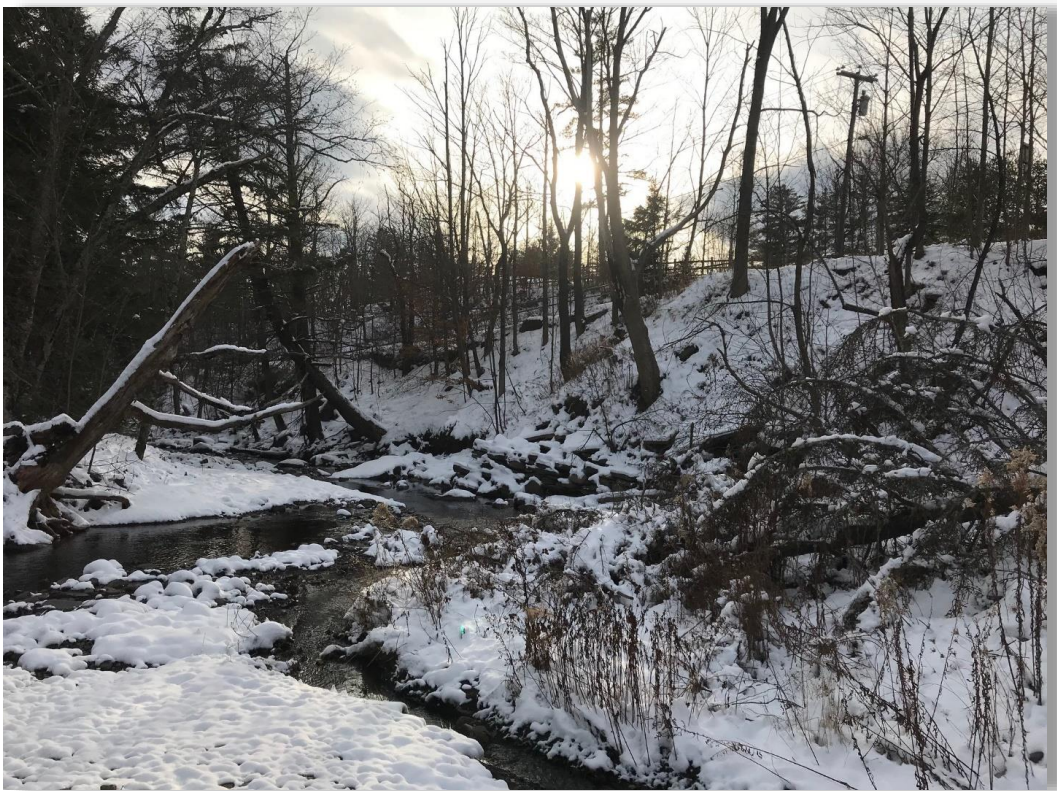
Figure 6-1
Eroded Hillslope along Railroad Avenue, Viewed from GCSWCD Building

- An engineering analysis of the embankment and implementation of bank stabilization measures is recommended.

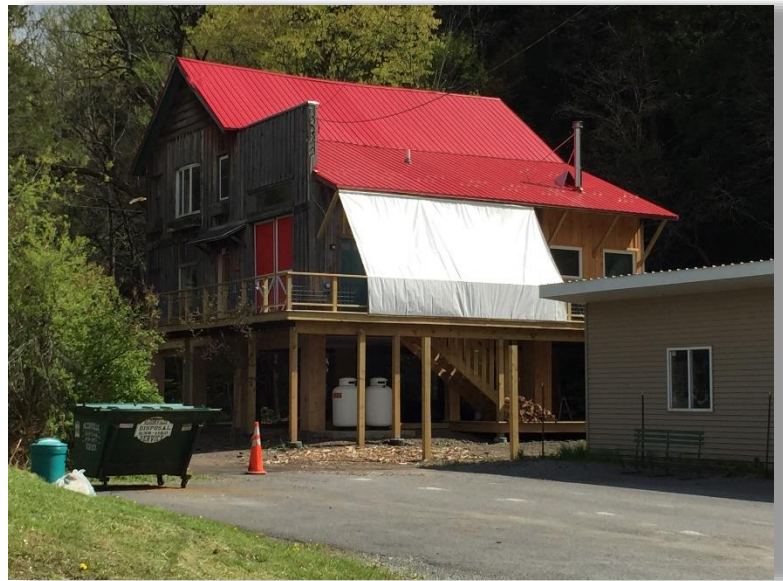
Figure 6-4
Example of an Elevated Structure

Elevation of the structure – Home elevation involves the removal of the building structure from the basement and elevating it on piers to a height such that the first floor is located 2 feet or more above the level of the 100-year flood event (Figure 6-4). The basement area is abandoned and filled to be no higher than the existing grade. All utilities and appliances located within the basement must be relocated to the first floor level or installed from basement joists or similar mechanism at an elevation no less than 2 feet above the BFE.

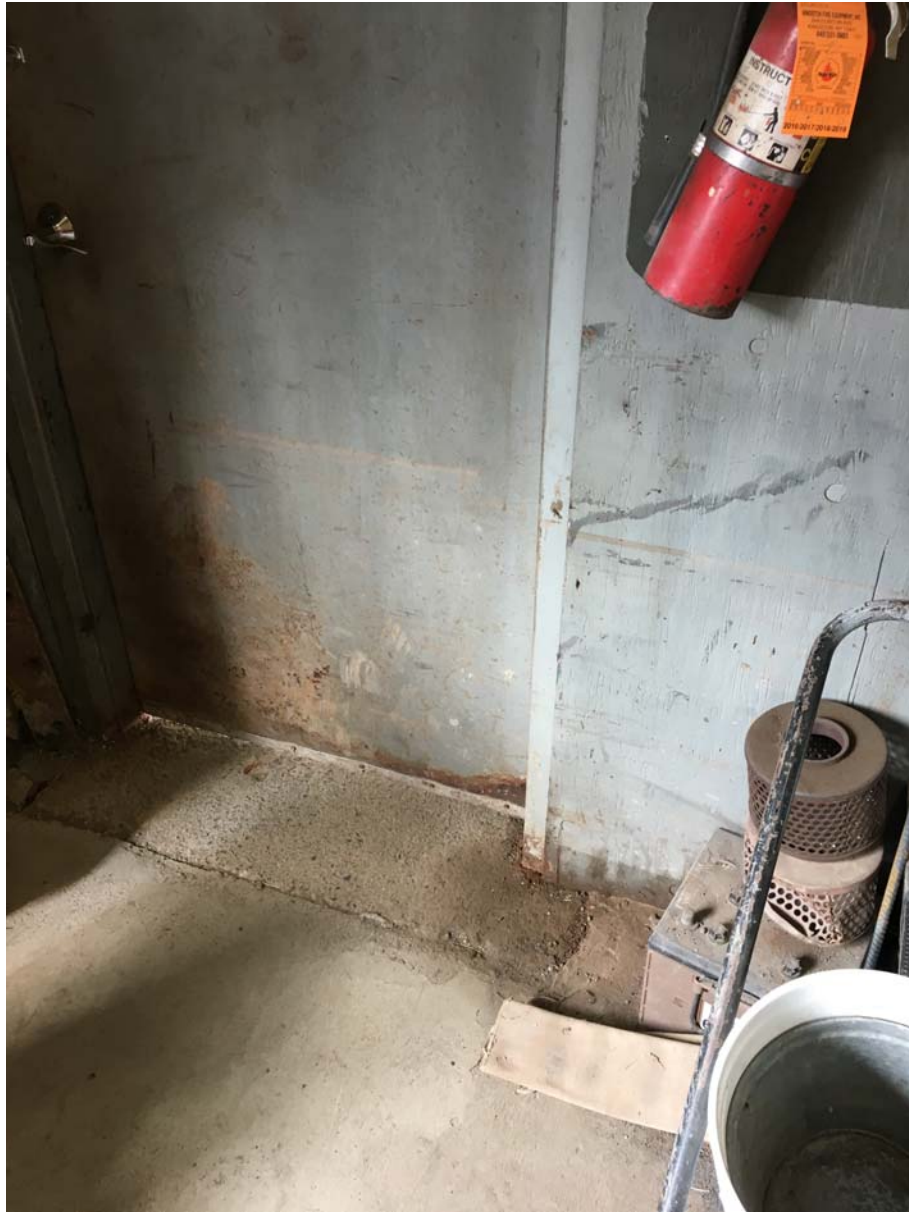
Photo #1 – Typical Water Mark on Interior of Building

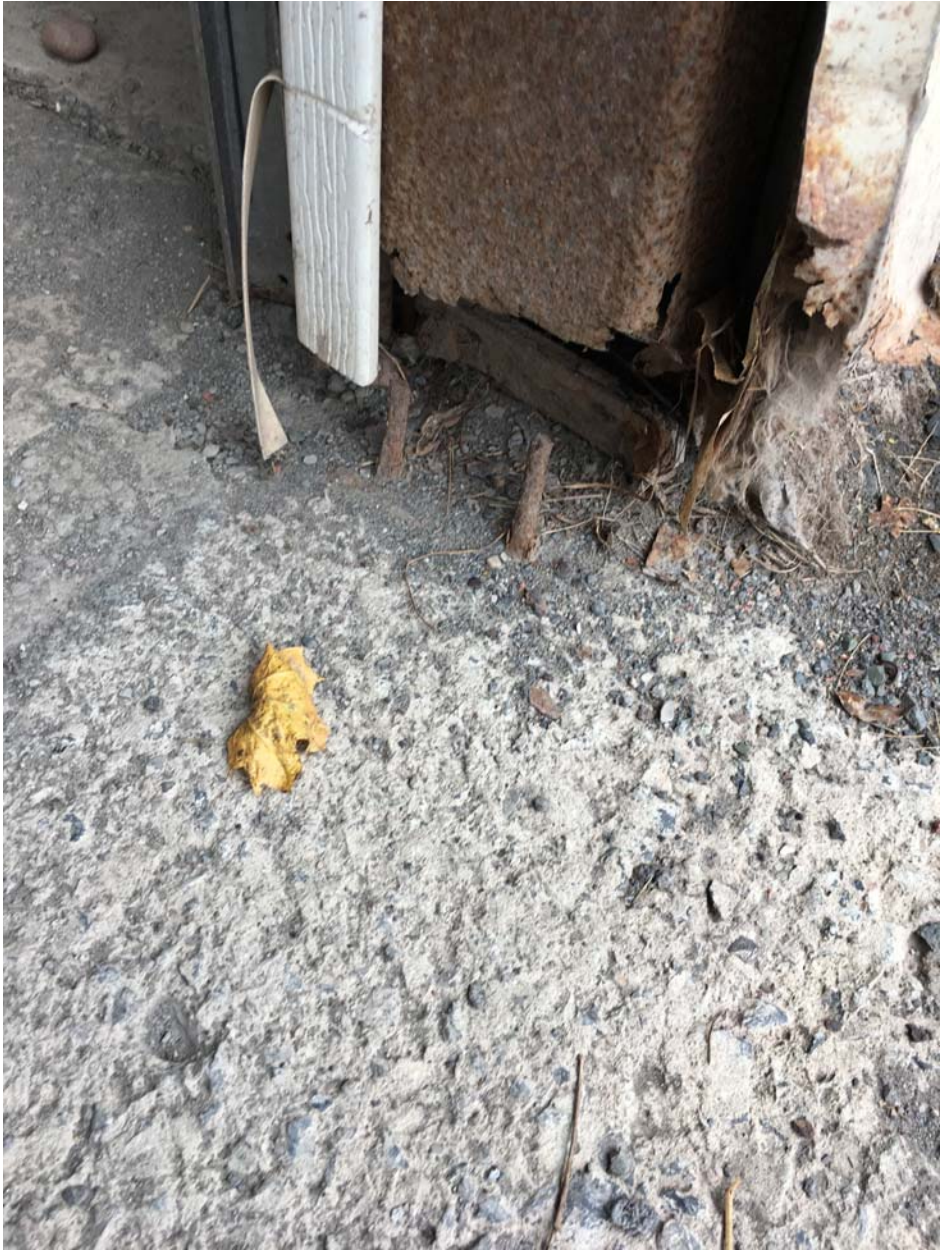
Photo #2 – Typical Example of Rusted Baseplate

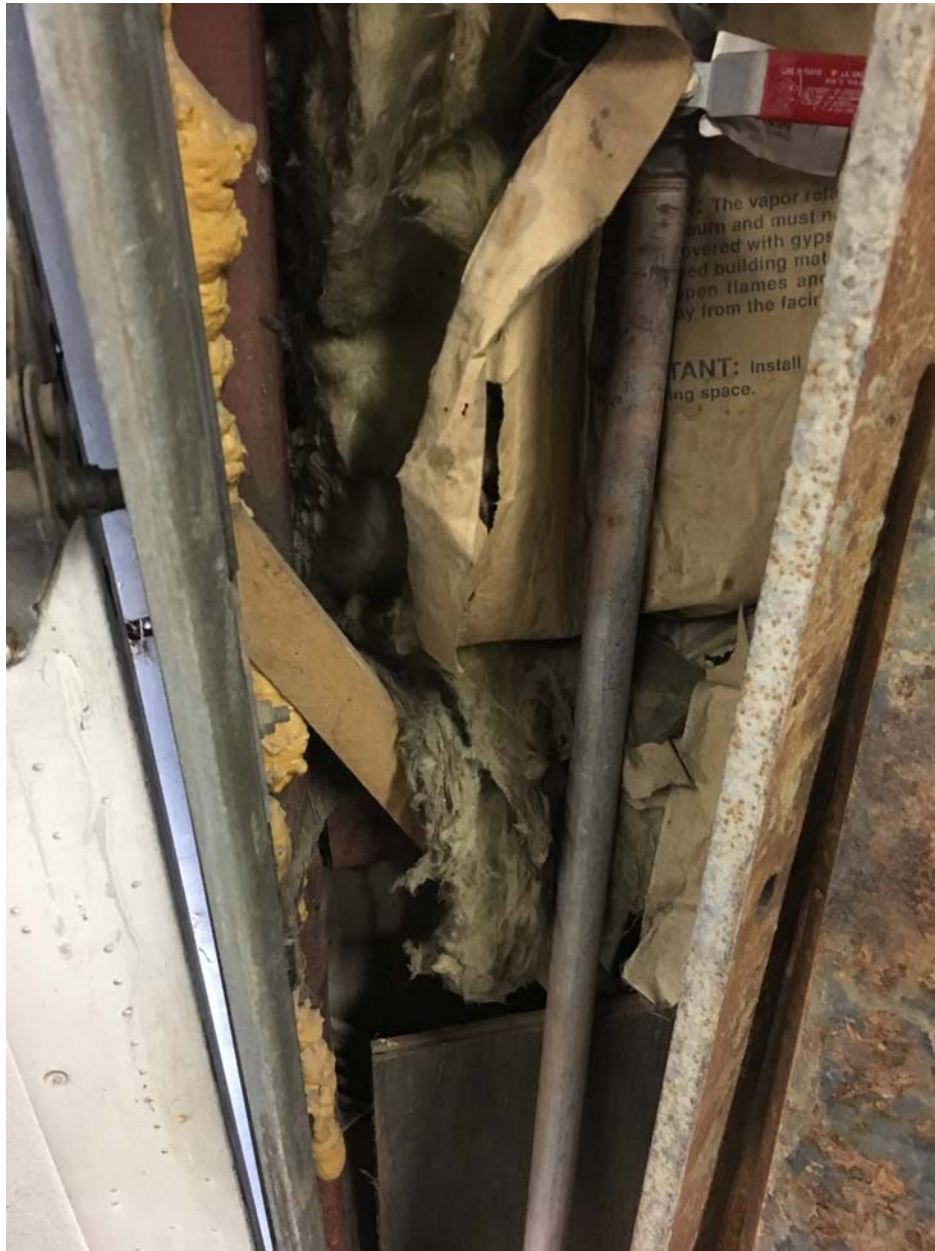
Photo #2 – Typical Damaged Insulation
